# UPDATE

September 14, 1995

## NIOSH Warns Farmers of Forage Wagon Hazards

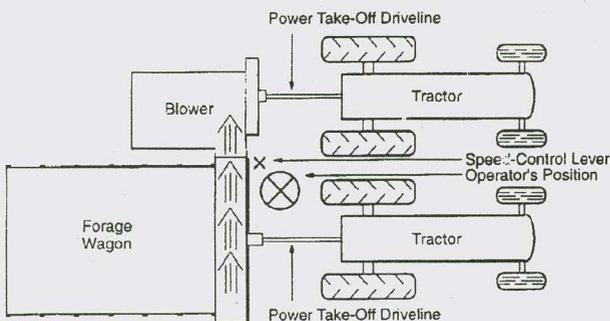
The injuries described here are caused by a combination of factors. It is well known that unguarded PTOs may cause severe entanglement injuries. Additionally, in order to unload silage, the forage wagon, silo blower, and both tractors must be close to one another. The speed-control lever for the forage wagon is often located between the wagon and the blower. Because of the size of the equipment, there is usually not room to walk between the tractors to operate the forage wagon controls. Consequently, the operator often steps over the revolving PTO driveline which may lead to injury or even death.

*Typical arrangement of equipment used to transfer feed from a forage wagon into a blower*

- Equip PTO drivelines with proper, functioning guards.
- Avoid stepping over rotating PTO drivelines.
  - Pre-set the mechanical speed control device on the wagon to allow unloading without leaving the tractor seat.

- Install a conveyor extension to forage wagons to increase the walking space between the two tractors. The extension will also increase efficiency.
  - Manufacturers should promote other speed controls such as hydraulic kits that permit operating the wagon from an alternate location.
